# Aviation Investigation Final Report

<b>Location:</b>	Springfield, Illinois	<b>Accident Number:</b>	CEN20FA070
<b>Date &amp; Time:</b>	January 28, 2020, 15:03 Local	<b>Registration:</b>	N6071R
<b>Aircraft:</b>	Piper PA60	<b>Aircraft Damage:</b>	Destroyed
<b>Defining Event:</b>	Loss of control in flight	<b>Injuries:</b>	3 Fatal
<b>Flight Conducted Under:</b>	Part 91: General aviation - Personal

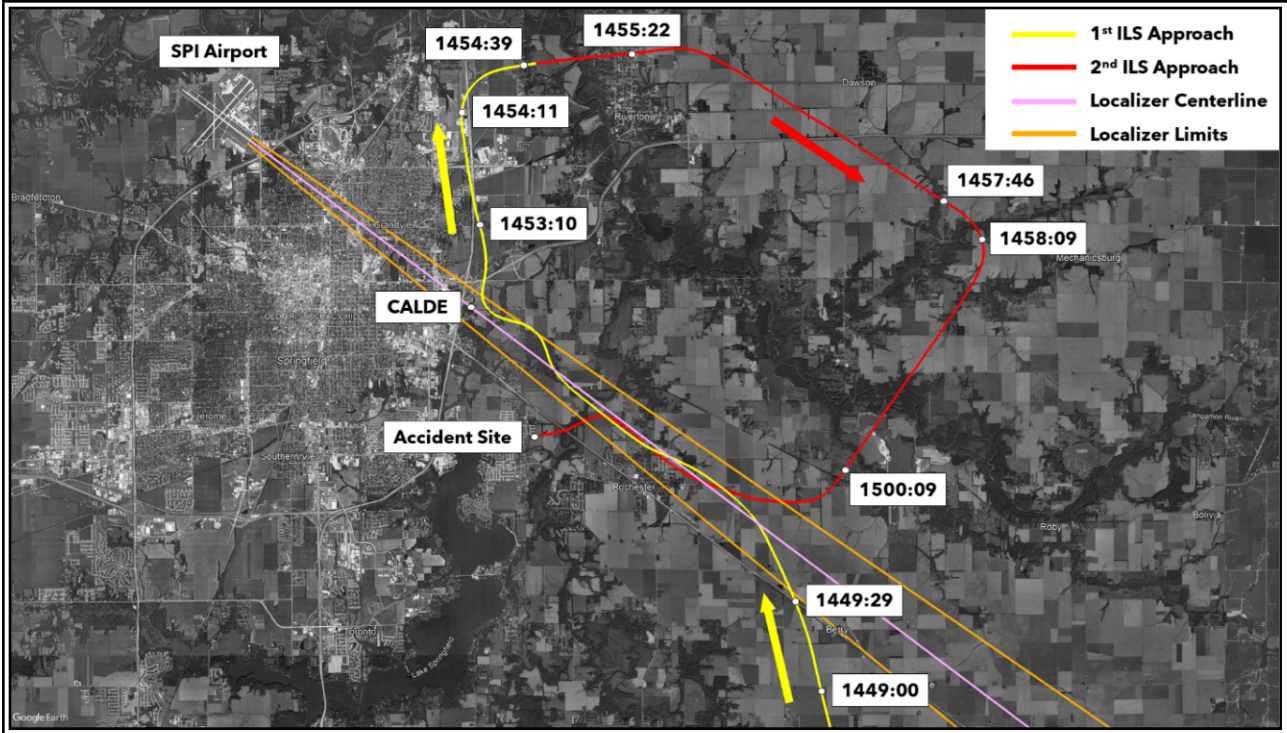
**Figure 1.** ADS-B track data with localizer centerline and limits.

At 1449:29, the pilot transmitted, "we're not picking these navs [navigation signals] on thirty one." At that time, the airplane was still flying along the assigned 340° heading to intercept the localizer and was about 0.6 nautical miles (nm) left of the localizer, as shown in figure 1. At 1449:36, the approach controller asked the pilot to repeat his previous transmission, and the pilot replied, "we still got neg nav [negative navigation] lights on thirty one." At 1449:53, the approach controller transmitted "we're getting green indications here... (unintelligible) just to verify that you are on one one zero point one five on the localizer?"

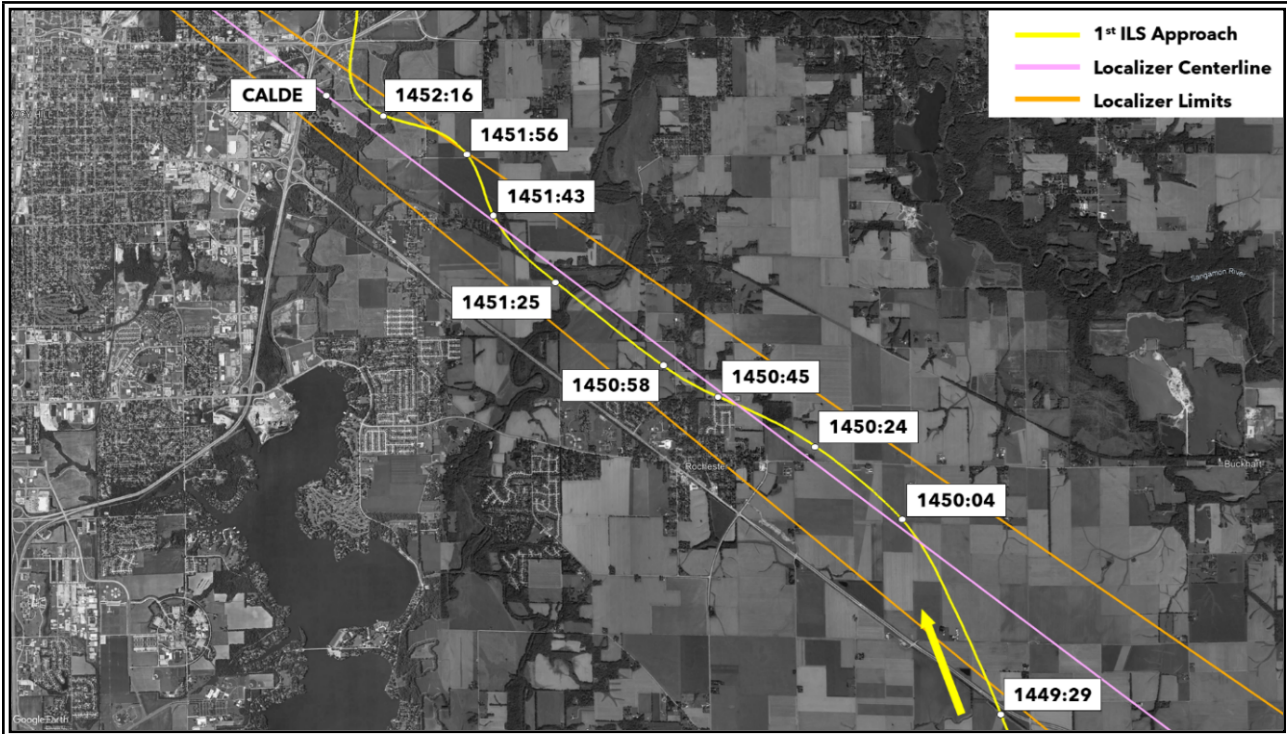
**Figure 2.** ADS-B track data for first ILS approach to runway 31.

At 1449:59, the airplane flew through the localizer centerline while still on the assigned 340° heading, as shown in figure 2. After crossing through the localizer centerline, the airplane made a left turn to a 295° course.

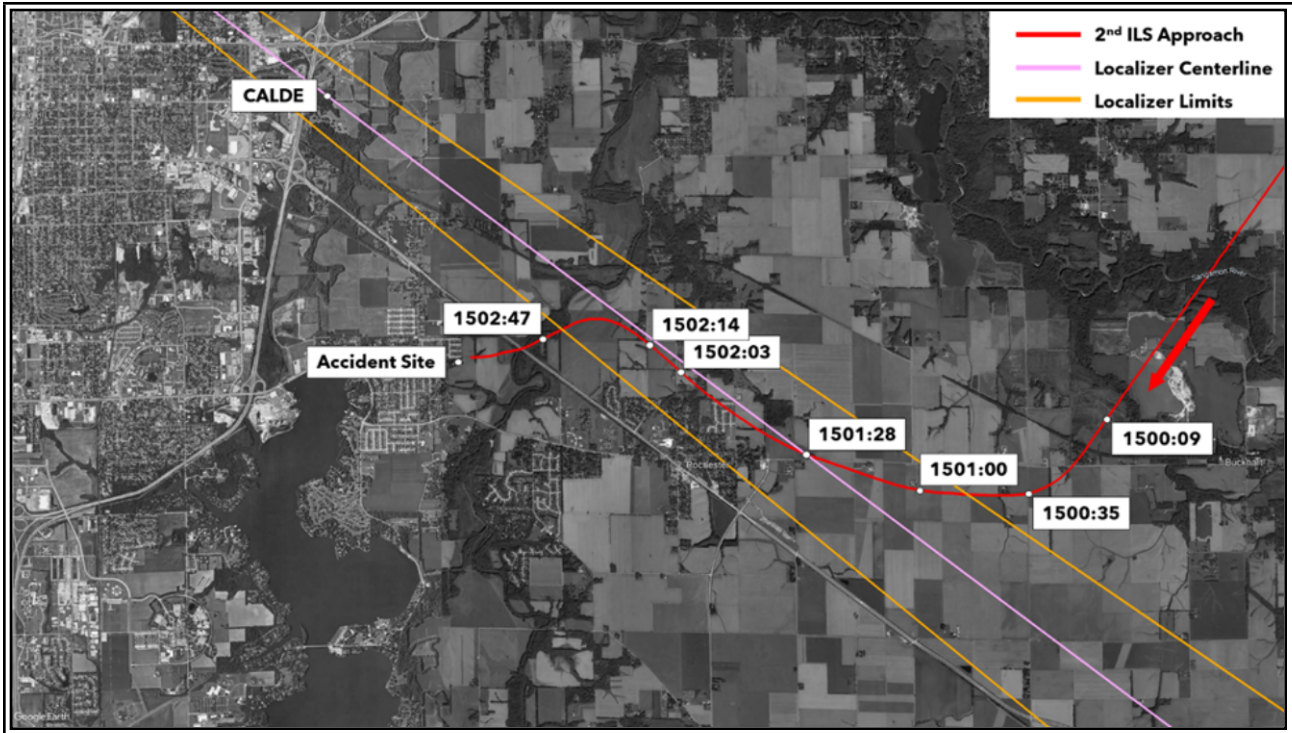
**Figure 3.** ADS-B track data for second ILS approach to runway 31.

Between 1500:35 and 1501:00, the airplane's course was about 270° as it approached the localizer from the east, as shown in figure 3. At 1501:00, the airplane turned right to a 290° course and subsequently flew through the localizer centerline at 1501:28. When the airplane flew through the localizer centerline, about 4.4 nm from CALDE, the airplane was descending through 2,650 ft msl. The airplane continued toward CALDE slightly left of the localizer centerline. At 1502:03, the approach controller transmitted, "Aerostar seven one romeo, is everything looking good now, we are showing you on course." At 1502:07, the pilot replied, "yup, looking good."

At 1502:11, the approach controller instructed the pilot to contact Springfield tower, and the pilot acknowledged this instruction. At that time, the airplane was about 3 nm from CALDE, descending through 2,300 ft msl, and 0.05 nm to the left the localizer centerline. About 1502:16, the airplane entered a left turn away from the localizer and descended below the glideslope intercept altitude (2,100 ft msl), as shown in figures 3 and 4.

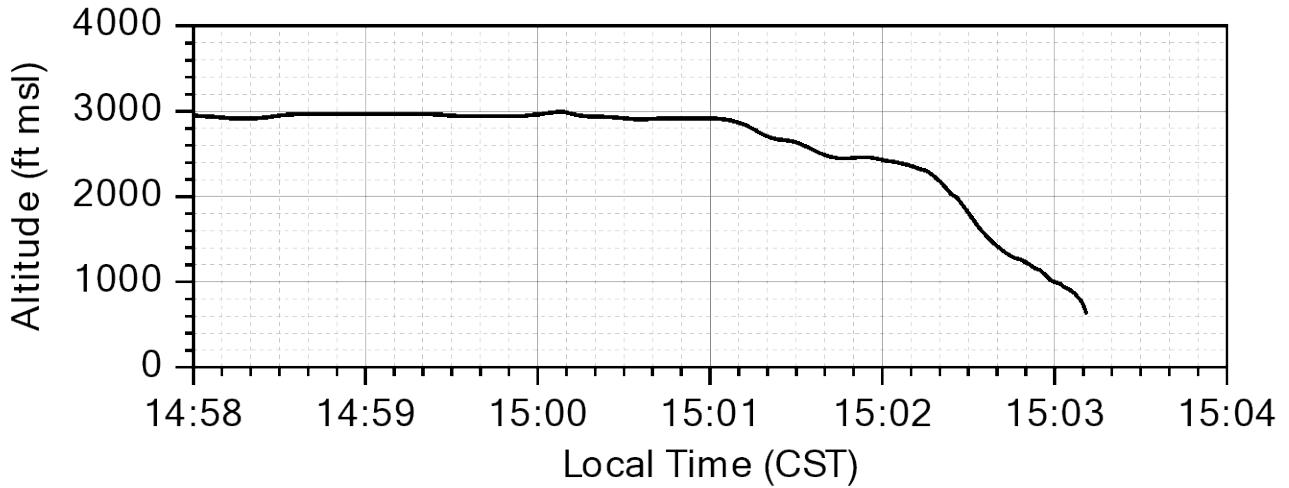
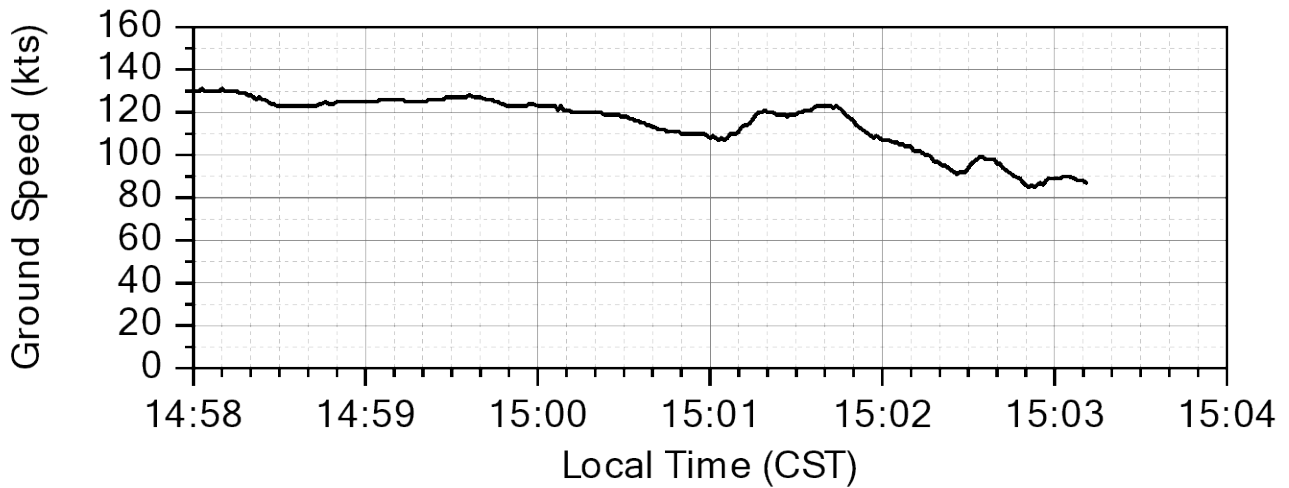
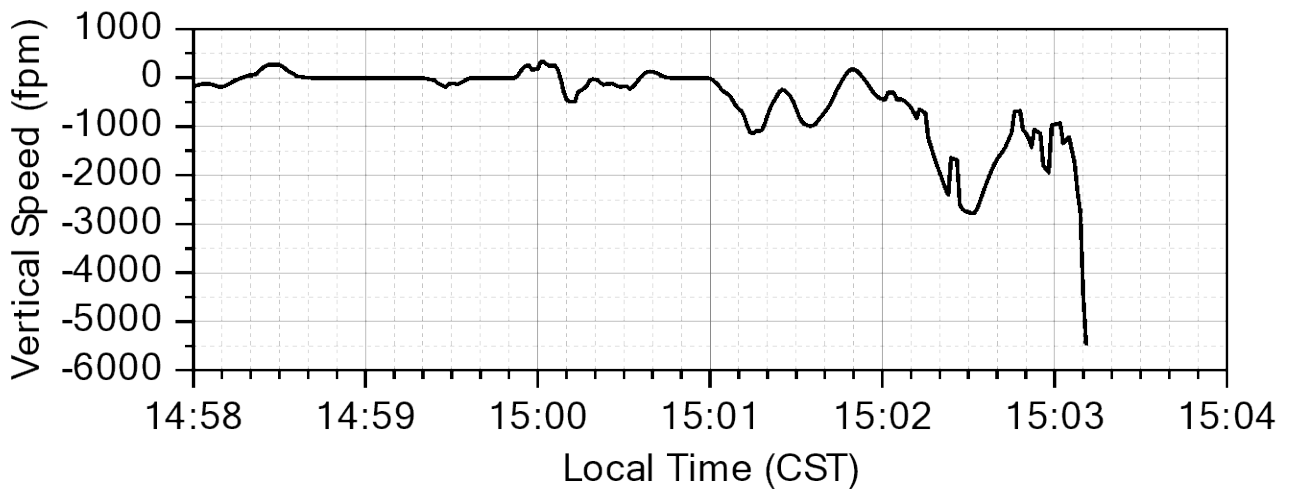
**Figure 5.** Altitude, groundspeed, and vertical speed data for the second ILS approach.

The final recorded ADS-B data point, at 1503:11, indicated that the airplane was at an altitude of 641 ft msl (about 66 ft above ground level [agl]) with a groundspeed and ground track of 87 knots and 267°, respectively, as shown in figure 5. During the final 5 seconds of recorded data, the airplane's descent rate changed rapidly from 1,500 to about 5,450 fpm. The final ADS-B data point was located about 380 ft east-northeast of the location where the airplane impacted terrain. A postcrash fire ensued.

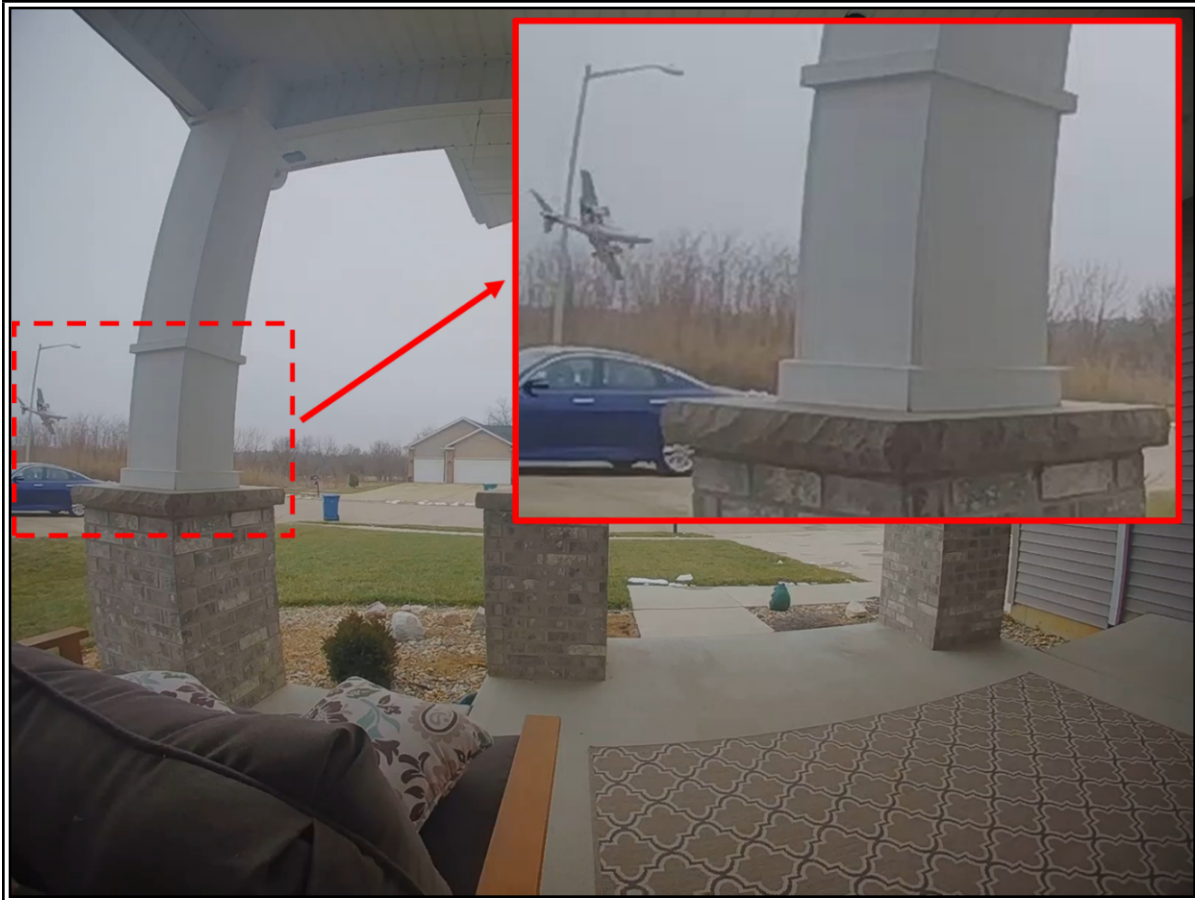
**Figure 6.** Doorbell camera image of accident airplane shortly before impact.

A doorbell security camera located about 260 ft north of the accident site captured video and audio of the final seconds of the flight. A review of the camera footage revealed that the airplane descended toward the ground in a left-wing-down and slightly nose-down attitude, as shown in figure 6. All three landing gear were observed to be extended before impact. The initial impact with the ground was obscured by a porch post and trees; when the airplane reemerged, it was sliding on its lower fuselage. Smoke from a postimpact fire was observed seconds after the accident.
