# Aviation Investigation Final Report

<b>Location:</b>	Lawrenceville, Illinois	<b>Accident Number:</b>	CEN20LA367
<b>Date &amp; Time:</b>	August 29, 2020, 01:23 Local	<b>Registration:</b>	N607SR
<b>Aircraft:</b>	Cirrus SR22	<b>Aircraft Damage:</b>	Destroyed
<b>Defining Event:</b>	Controlled flight into terr/obj (CFIT)	<b>Injuries:</b>	1 Fatal
<b>Flight Conducted Under:</b>	Part 91: General aviation - Personal

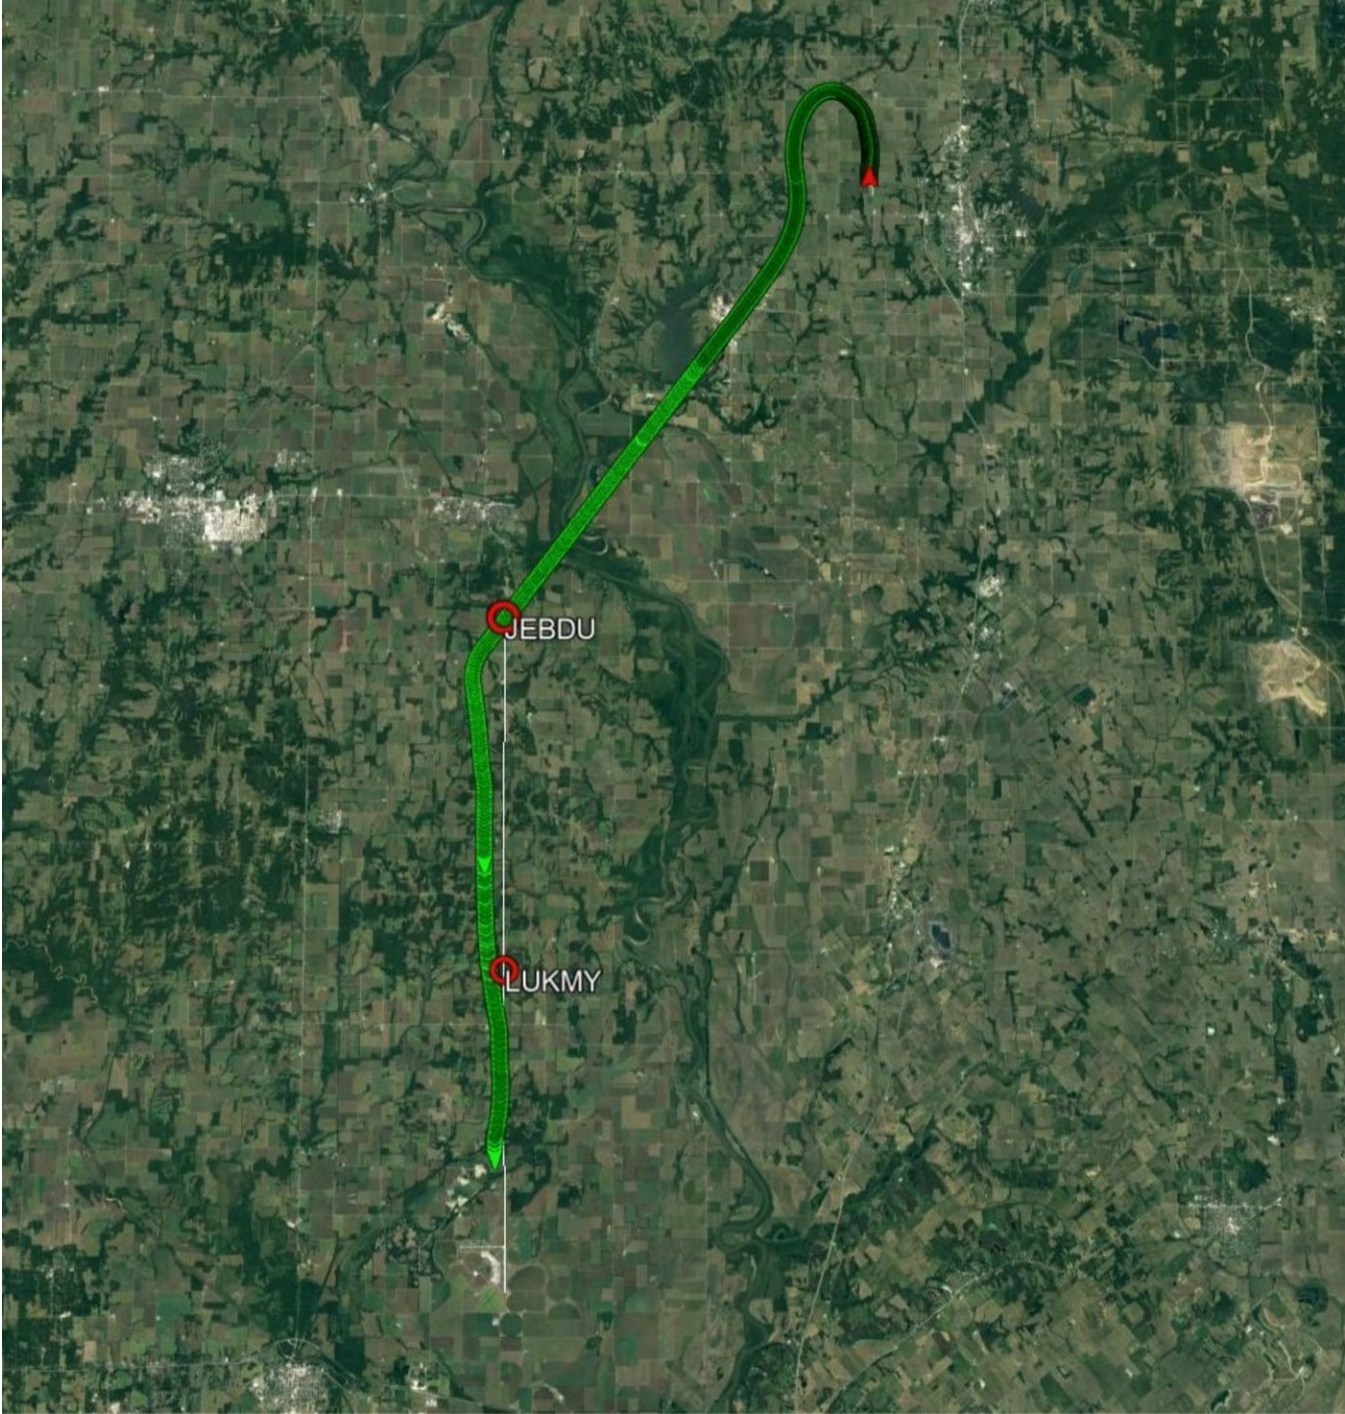
Figure 1. Airplane flight track (Google Earth image)

From 0118 to 0121, the airplane descended and reduced airspeed as it continued toward LWV and west of the final approach course. About 0121, at LUKMY, the final approach fix, the airplane was at 2,200 ft and west of the LUKMY. For the next 2 minutes, the airplane descended from 2,200 ft to 600 ft at an average rate of 800 ft per minute and an average ground speed of 116 knots. The airplane's final recorded altitude was 600 ft (See figures 1 and 2).
